SUBJECT: An industrial washing machine operator died when pulled inside a machine while loading sheets.

SUMMARY
California FACE Report #01CA010

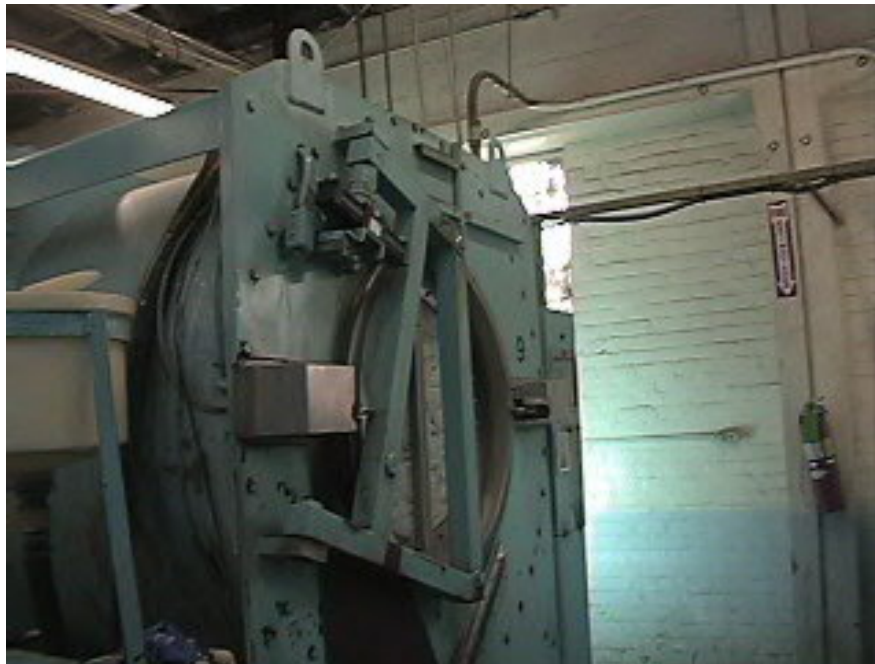
Exhibit #1

Front view of industrial washing machine involved in the incident

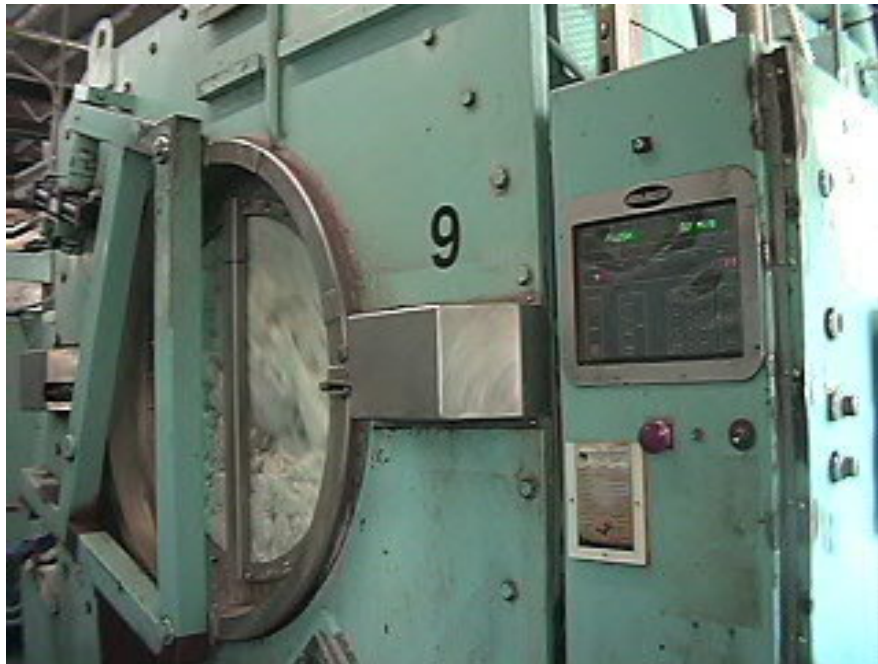
Exhibit #2

Discussion: When the basket button is depressed and released, the washing machine drum rotates approximately three revolutions. Holding the switch in will allow the drum to continue to rotate until released. Changing the switch to a mechanism that would only allow the drum to inch forward with every depression would remove any potential hazard created with a rotating drum when the drum door is opened.

Front view of industrial washing machine and control panel

Recommendation #2: Consider changing the basket button to a switch that only allows the drum to inch forward with every depression.

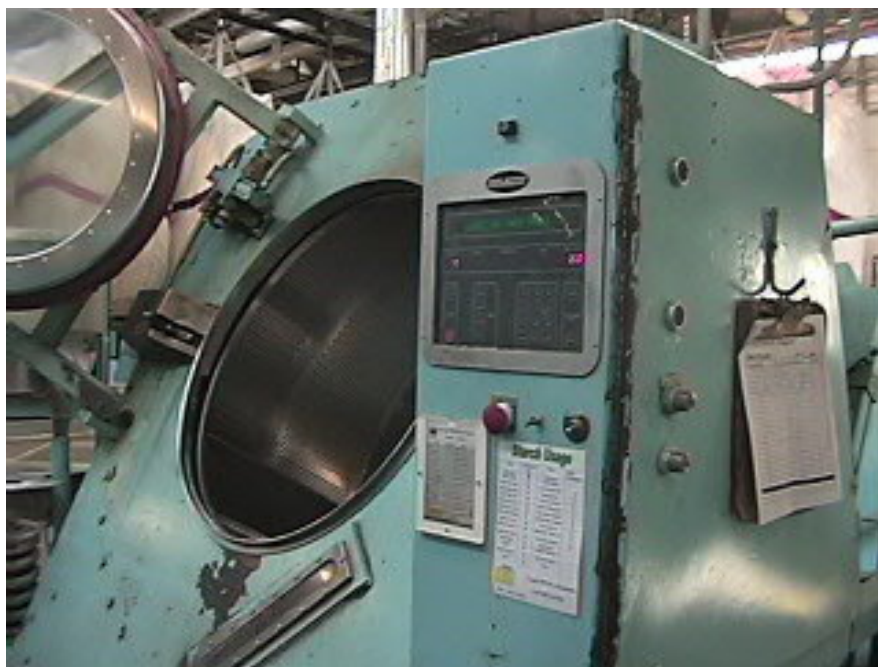
Exhibit #3

View of industrial washing machine in tilt position with loading door open.

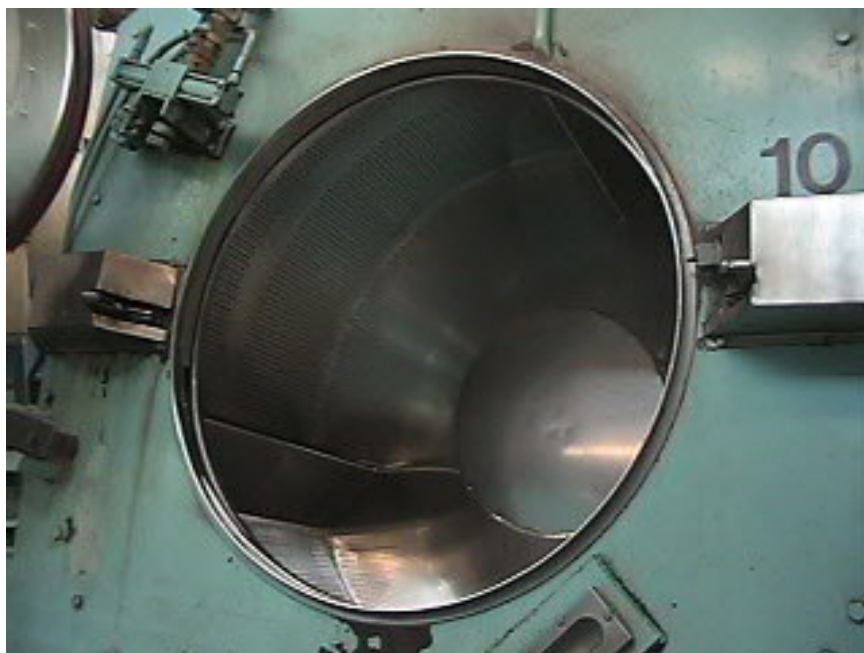
Exhibit #4

View of the industrial washing machine's rotating drum

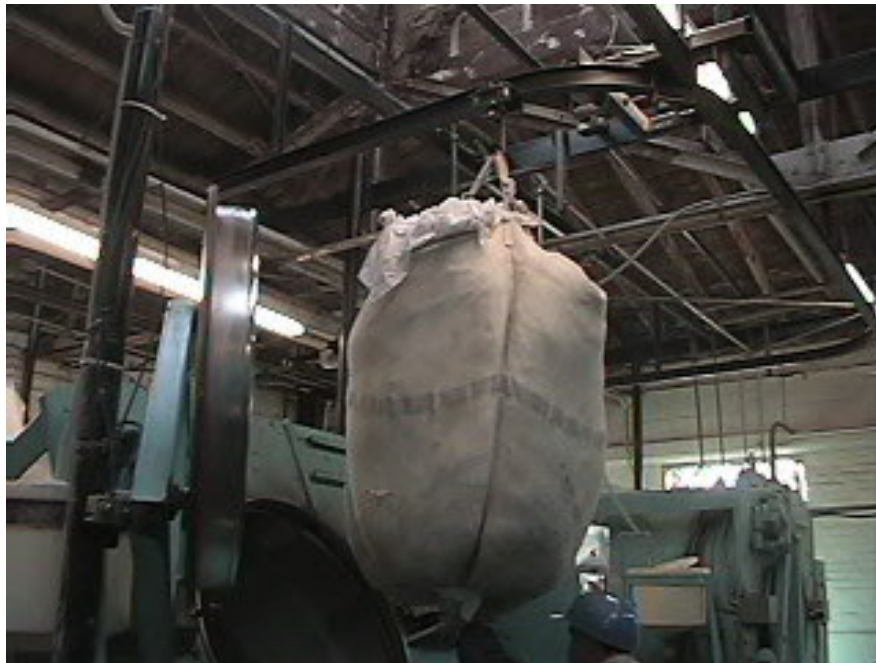
Exhibit #5

View of the laundry sling used to deliver laundry to the machine.

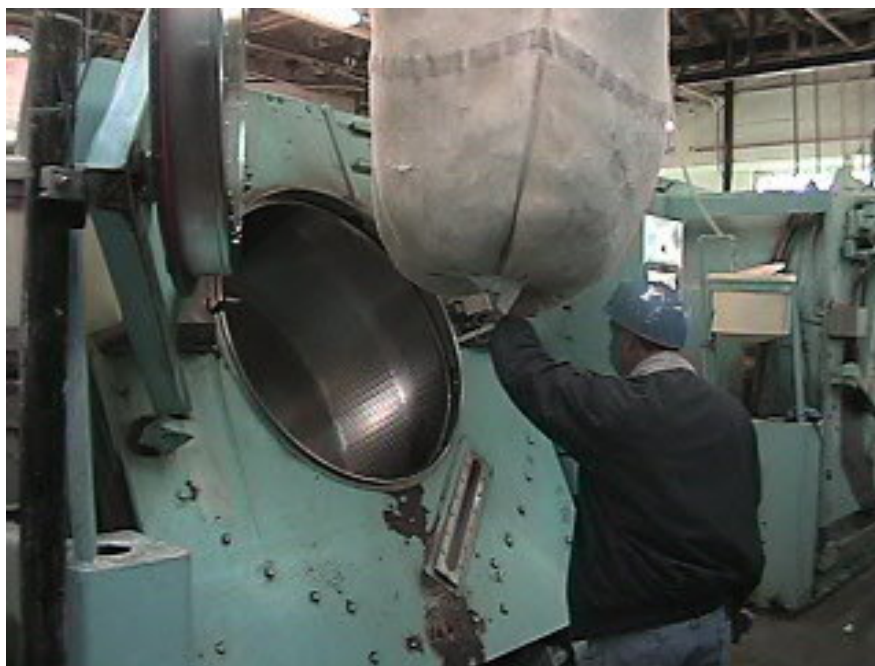
Exhibit #6

View of the laundry sling in front of the industrial washing machine.

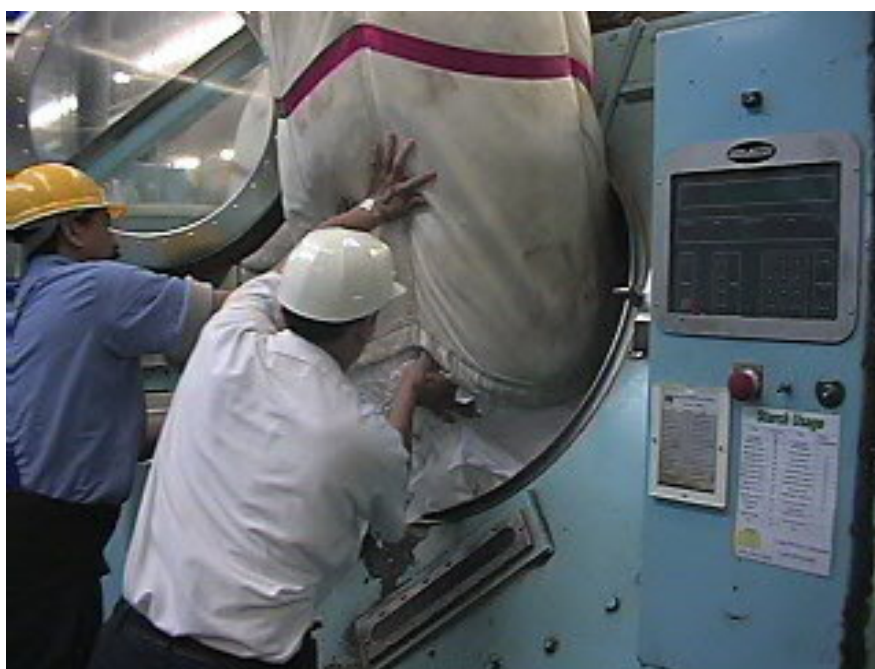
Exhibit #7

View of the laundry sling being unloaded into the industrial washing machine.

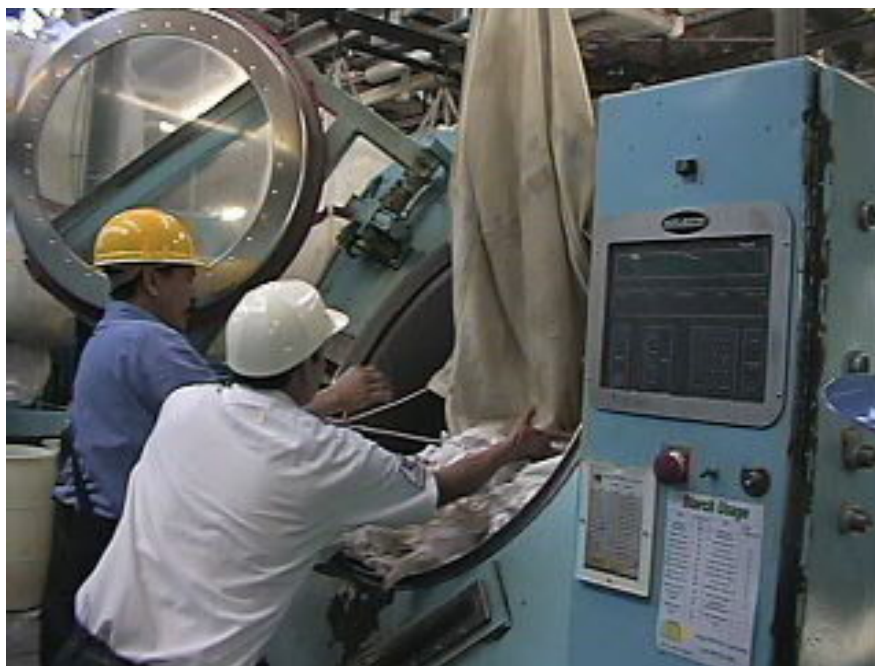
Exhibit #8

Discussion: The victim attempted to load the sling of sheets alone. He activated the basket button, the drum rotated; he became entangled in the sheets and was pulled inside. Supervisors need to assure that employees follow all rules and regulations involving safety. Employers can ensure worker compliance with safe work practices through programs of training, supervision, safe work recognition, and progressive disciplinary measures.

View showing two workers emptying laundry sling into tilted industrial washing machine.

Recommendation #1: Ensure employees do not attempt to work alone for those types of loads that require two people.
